## APPLICATION NOTE:

# EFFECT OF MECHANICAL NAIL PENETRATION ON BATTERY THERMAL STABILITY IN BTC

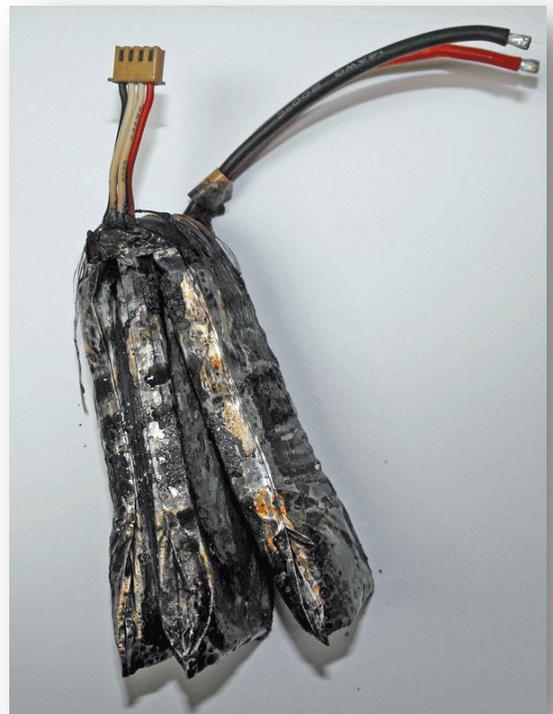
FIGURE 3. DAMAGED BATTERY PACK AFTER THE TEST

The second test was very similar except that the battery pack was purposely damaged by penetration with a large (5mm diameter) nail which was pushed through. The battery pack was placed on a steel

“tray” before the penetration and then the tray (and battery) were placed in the BTC to start the thermal stability test.
